Manhole Inspection Summary

Manhole # S53C__018MH

Location Address: **3329 ALLEY-CLINTON-HIGHLAND**

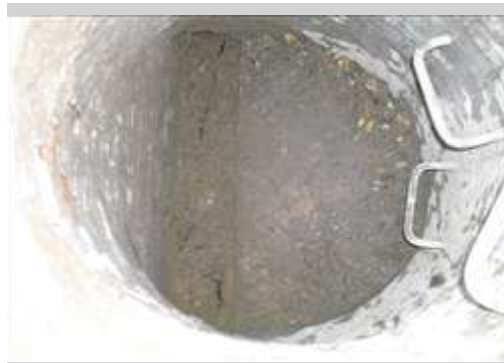
Top View

POST CLEANING

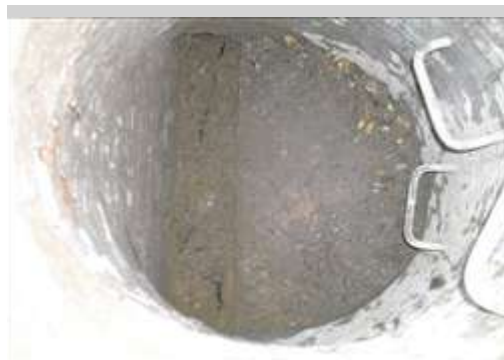
Defect 5

Bench ☒ Exists Material: **Brick** ☐ Parged
Condition: ☐ Sound ☐ Cracked ☐ Root Intrusion ☐ Deteriorated ☐ Leaks ☒ **Debris**

DEBRIS ON BENCH

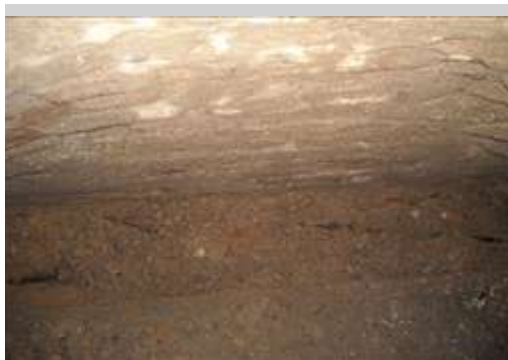
Defect 4

Channel Material: **Brick** ☐ Parged
Channel Exposure: **Fully Open** Junc Dist: **0** nearest .5 ft. Azimuth: **0**
Condition: ☐ Sound ☐ Cracked ☐ Root Intrusion ☐ Deteriorated ☐ Leaks ☒ **Debris**

DEBRIS IN CHANNEL

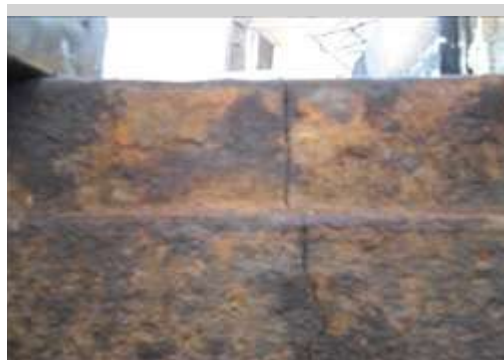
Defect 3

Frame Offset: **0** (in.) Condition: ☐ Sound ☒ **Cracked** ☒ **Leaks**

CRACKED FRAME

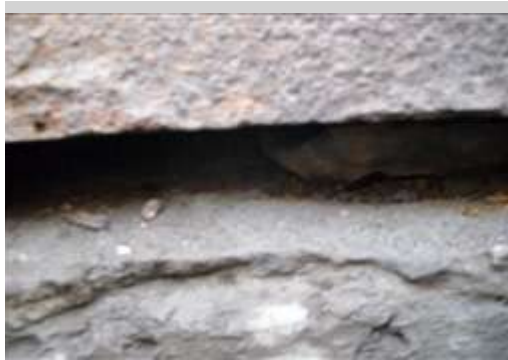
Defect 2

FRAME LEAKS; NO CHIMNEY OR
PARGING TO SEAL FRAME TO
STRUCTURE.

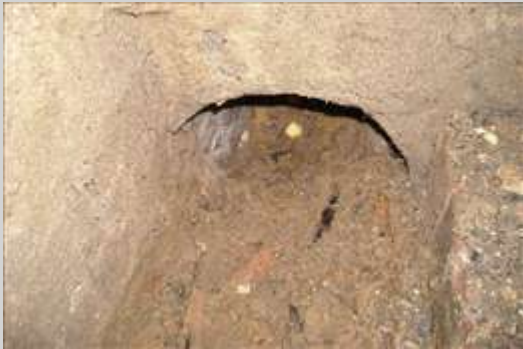
12 O'Clock Outflow

8 in. Circular Gravity Sewer
Pipe Out @ 12 O'Clock

Deposits: ☐ None ☒ **Mud** ☐ Sludge ☐ Debris ☐ Grease

Silt Depth: **1** (in.) Deposits Extent: **Light**
